Management Survey

Torwood Hall Care Home
Carronvale Road
Larbert
Stirlingshire
FK5 3LG

Environmental Essentials Ltd.

Report issue date:	23 June 2015

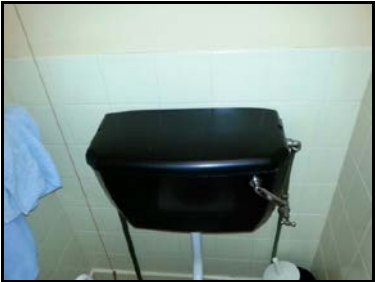
Sample No	Building	Floor	Analysis
	p-166740/001	Torwood Hall Care Home	Ground Floor	Chrysotile
	Area/Location/Position	Material description	Quantity	Confirmation of product type
	004 - Toilet - Toilet cistern	Reinforced plastic	1 Number	Asbestos reinforced plastic
	Product type	Condition	Surface Treatment	Asbestos type
	1	0	0	1
Material Risk Score	Priority Risk Score	Total Risk Score	Accessibility	
2	-	2	1 - Occasional disturbance	
Recommended action	Monitor condition.			
Recommendation comments	-			
Surveyor comments	-

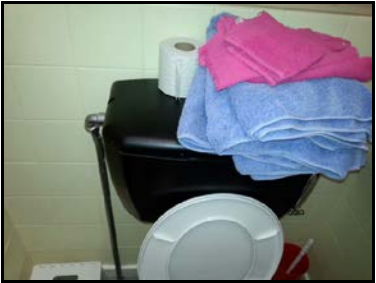
Sample No	Building	Floor	Analysis
	p-166740/002	Torwood Hall Care Home	Ground Floor	Chrysotile
	Area/Location/Position	Material description	Quantity	Confirmation of product type
	008 - Toilet - Toilet cistern	Reinforced plastic	1 Number	Asbestos reinforced plastic
	Product type	Condition	Surface Treatment	Asbestos type
	1	0	0	1
Material Risk Score	Priority Risk Score	Total Risk Score	Accessibility	
2	-	2	1 - Occasional disturbance	
Recommended action	Monitor condition.			
Recommendation comments	-			
Surveyor comments	-

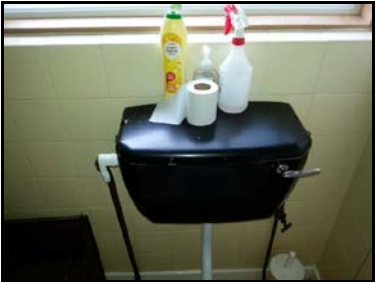
Sample No	Building	Floor	Analysis
	p-166740/003	Torwood Hall Care Home	Ground Floor	Chrysotile
	Area/Location/Position	Material description	Quantity	Confirmation of product type
	011 - Toilet - Toilet cistern	Reinforced plastic	1 Number	Asbestos reinforced plastic
	Product type	Condition	Surface Treatment	Asbestos type
	1	0	0	1
	Material Risk Score	Priority Risk Score	Total Risk Score	Accessibility
2	-	2	1 - Occasional disturbance	
Recommended action	Monitor condition.			
Recommendation comments	-			
Surveyor comments	-

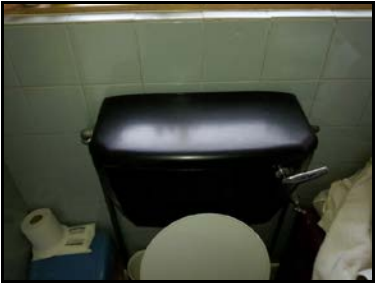
Sample No	Building	Floor	Analysis
	p-166740/004	Torwood Hall Care Home	Ground Floor	Chrysotile
	Area/Location/Position	Material description	Quantity	Confirmation of product type
	013 - Toilet - Toilet cistern	Reinforced plastic	1 Number	Asbestos reinforced plastic
	Product type	Condition	Surface Treatment	Asbestos type
	1	0	0	1
	Material Risk Score	Priority Risk Score	Total Risk Score	Accessibility
2	-	2	1 - Occasional disturbance	
Recommended action	Monitor condition.			
Recommendation comments	-			
Surveyor comments	-

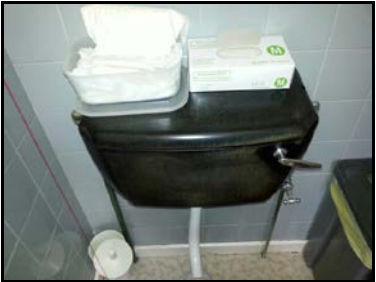
Sample No	Building	Floor	Analysis
	p-166740/007	Torwood Hall Care Home	Ground Floor	Chrysotile
	Area/Location/Position	Material description	Quantity	Confirmation of product type
	019 - Toilet - Toilet cistern	Reinforced plastic	1 Number	Asbestos reinforced plastic
	Product type	Condition	Surface Treatment	Asbestos type
	1	0	0	1
Material Risk Score	Priority Risk Score	Total Risk Score	Accessibility	
2	-	2	1 - Occasional disturbance	
Recommended action	Monitor condition.			
Recommendation comments	-			
Surveyor comments	Two layers of modern vinyl flooring are present with a layer of non asbestos building paper below.

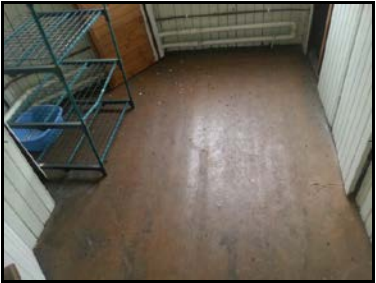
Sample No	Building	Floor	Analysis
	p-166740/024	Torwood Hall Care Home	Second Floor	No asbestos detected
	Area/Location/Position	Material description	Quantity	Confirmation of product type
	090 - Turret - Vinyl flooring on entry level and stairs	Vinyl product	N/A	Non-asbestos material
	Product type	Condition	Surface Treatment	Asbestos type
	-	-	-	-
	Material Risk Score	Priority Risk Score	Total Risk Score	Accessibility
0	-	0	-	
Recommended action	-			
Recommendation comments	-			
Surveyor comments	A plastic water tank with a MMMF jacket and uninsulated and hessian wrapped metal pipes is present.

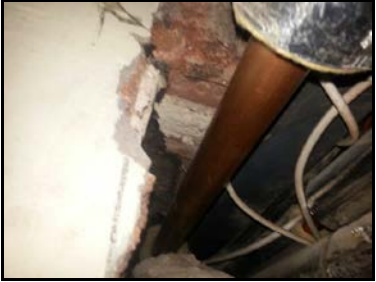
Sample No	Building	Floor	Analysis
	p-166740/026	Torwood Hall Care Home	First Basement Level	No asbestos detected
	Area/Location/Position	Material description	Quantity	Confirmation of product type
	092 - Circulation - Damp proof course	Bituminous products	N/A	Non-asbestos material
	Product type	Condition	Surface Treatment	Asbestos type
	-	-	-	-
	Material Risk Score	Priority Risk Score	Total Risk Score	Accessibility
0	-	0	-	
Recommended action	-			
Recommendation comments	-			
Surveyor comments	Damp proof course is visible around hole in wall for exiting pipes.

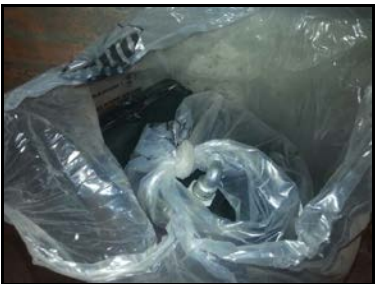
Sample No	Building	Floor	Analysis
	p-166740/028	Torwood Hall Care Home	Ground Floor	Chrysotile
	Area/Location/Position	Material description	Quantity	Confirmation of product type
	094 - Boiler room - Toilet cistern	Reinforced plastic	1 Number	Asbestos reinforced plastic
	Product type	Condition	Surface Treatment	Asbestos type
	1	1	0	1
Material Risk Score	Priority Risk Score	Total Risk Score	Accessibility	
3	-	3	1 - Occasional disturbance	
Recommended action	Remove.			
Recommendation comments	-			
Surveyor comments	Toilet cistern is present within an asbestos waste bag on boiler room floor.

Building	Floor	Item	Location	Sample Ref	Recommendations
Torwood Hall Care Home	0	Toilet cistern	094 - Boiler room	028	Remove.

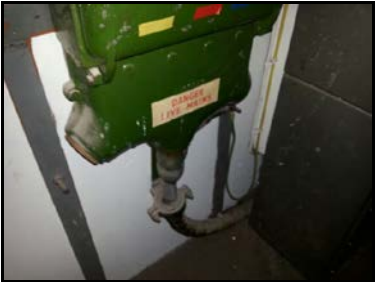
Sample No	Building	Floor	Analysis
	p-166740/P001	Torwood Hall Care Home	Ground Floor	Presumed to contain asbestos
	Area/Location/Position	Material description	Quantity	Confirmation of product type
	045 - Store - Bitumen cable wrap	Bituminous products	1 Number	N/A
	Product type	Condition	Surface Treatment	Asbestos type
	1	0	0	1
Material Risk Score	Priority Risk Score	Total Risk Score	Accessibility	
2	-	2	1 - Occasional disturbance	
Recommended action	Monitor condition.			
Recommendation comments	-			
Surveyor comments	Bitumen cable wrap presumed and no inspection made within electrics present in this location due to safety reasons as they were live at the time of the survey.

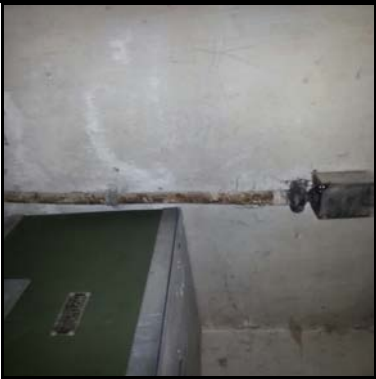
Sample No	Building	Floor	Analysis
	p-166740/P002	Torwood Hall Care Home	First Basement Level	Presumed to contain asbestos
	Area/Location/Position	Material description	Quantity	Confirmation of product type
	092 - Circulation - Bitumen cable wrap	Bituminous products	1 Number	N/A
	Product type	Condition	Surface Treatment	Asbestos type
	1	0	0	1
Material Risk Score	Priority Risk Score	Total Risk Score	Accessibility	
2	-	2	1 - Occasional disturbance	
Recommended action	Monitor condition.			
Recommendation comments	-			
Surveyor comments	-

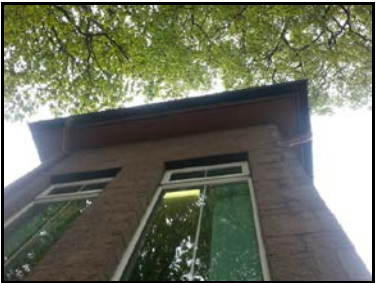
Sample No	Building	Floor	Analysis
	p-166740/P003	Torwood Hall Care Home	External	Presumed to contain asbestos
	Area/Location/Position	Material description	Quantity	Confirmation of product type
	096 - Externals - Insulating board soffits	Insulating board	20 m ²	N/A
	Product type	Condition	Surface Treatment	Asbestos type
	2	0	1	3
	Material Risk Score	Priority Risk Score	Total Risk Score	Accessibility
6	-	6	0 - Usually inaccessible	
Recommended action	Monitor condition.			
Recommendation comments	-			
Surveyor comments	Soffits to rear of building presumed due to height restrictions.
