Management Survey

Torwood Hall Care Home
Carronvale Road
Larbert
Stirlingshire
FK5 3LG

Environmental Essentials Ltd.

Report issue date:	23 June 2015

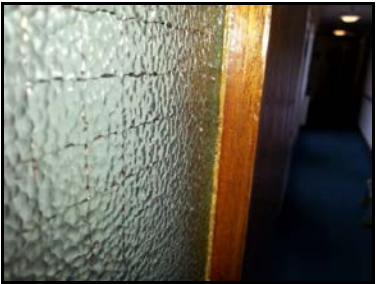
Sample No	Building	Floor	Analysis
	p-166740/005	Torwood Hall Care Home	Ground Floor	No asbestos detected
	Area/Location/Position	Material description	Quantity	Confirmation of product type
	015 - Entry - Putty to windows and doors	Mastics	N/A	Non-asbestos material
	Product type	Condition	Surface Treatment	Asbestos type
	-	-	-	-
Material Risk Score	Priority Risk Score	Total Risk Score	Accessibility	
0	-	0	-	
Recommended action	-			
Recommendation comments	-			
Surveyor comments	-

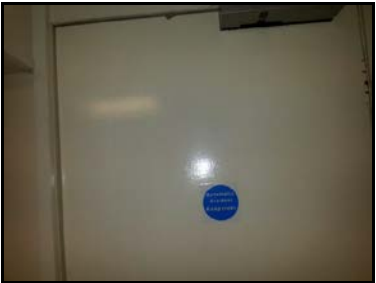
Sample No	Building	Floor	Analysis
	p-166740/008	Torwood Hall Care Home	Ground Floor	No asbestos detected
	Area/Location/Position	Material description	Quantity	Confirmation of product type
	029 - Office - Insulating board door panel	Insulating board	N/A	Non-asbestos material
	Product type	Condition	Surface Treatment	Asbestos type
	-	-	-	-
Material Risk Score	Priority Risk Score	Total Risk Score	Accessibility	
0	-	0	-	
Recommended action	-			
Recommendation comments	-			
Surveyor comments	-

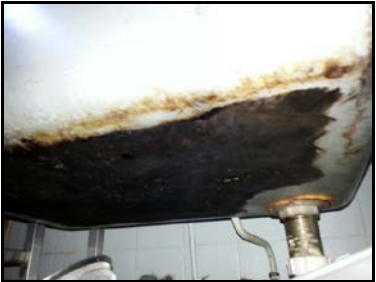
Sample No	Building	Floor	Analysis
	p-166740/012	Torwood Hall Care Home	Ground Floor	No asbestos detected
	Area/Location/Position	Material description	Quantity	Confirmation of product type
	050 - Staff room - Sink pad	Bituminous products	N/A	Non-asbestos material
	Product type	Condition	Surface Treatment	Asbestos type
	-	-	-	-
Material Risk Score	Priority Risk Score	Total Risk Score	Accessibility	
0	-	0	-	
Recommended action	-			
Recommendation comments	-			
Surveyor comments	-

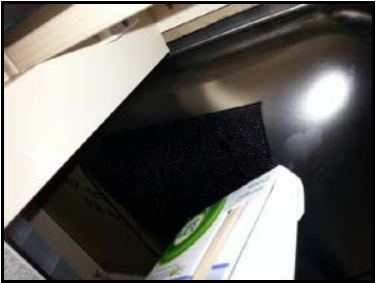
Sample No	Building	Floor	Analysis
	p-166740/013	Torwood Hall Care Home	Ground Floor	No asbestos detected
	Area/Location/Position	Material description	Quantity	Confirmation of product type
	054 - Kitchen - Sink coatings	Bituminous products	N/A	Non-asbestos material
	Product type	Condition	Surface Treatment	Asbestos type
	-	-	-	-
Material Risk Score	Priority Risk Score	Total Risk Score	Accessibility	
0	-	0	-	
Recommended action	-			
Recommendation comments	-			
Surveyor comments	-

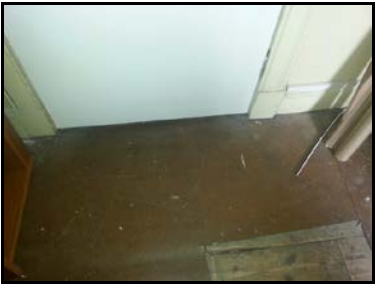
Sample No	Building	Floor	Analysis
	p-166740/017	Torwood Hall Care Home	Ground Floor	No asbestos detected
	Area/Location/Position	Material description	Quantity	Confirmation of product type
	075 - Circulation - Insulating board door panels leading to turret and bathroom	Insulating board	N/A	Non-asbestos material
	Product type	Condition	Surface Treatment	Asbestos type
	-	-	-	-
	Material Risk Score	Priority Risk Score	Total Risk Score	Accessibility
0	-	0	-	
Recommended action	-			
Recommendation comments	-			
Surveyor comments	-

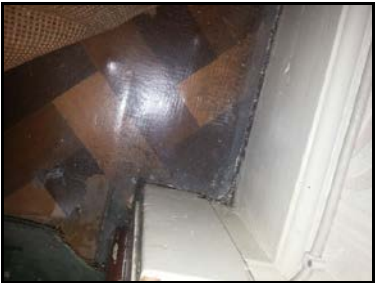
Sample No	Building	Floor	Analysis
	p-166740/018	Torwood Hall Care Home	Second Floor	No asbestos detected
	Area/Location/Position	Material description	Quantity	Confirmation of product type
	076 - Store - Vinyl flooring	Vinyl product	N/A	Non-asbestos material
	Product type	Condition	Surface Treatment	Asbestos type
	-	-	-	-
	Material Risk Score	Priority Risk Score	Total Risk Score	Accessibility
0	-	0	-	
Recommended action	-			
Recommendation comments	-			
Surveyor comments	-

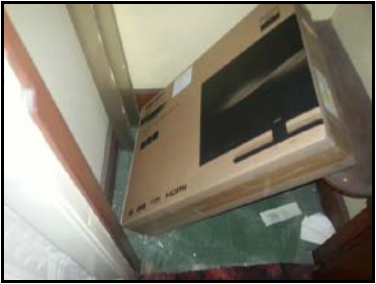
Sample No	Building	Floor	Analysis
	p-166740/019	Torwood Hall Care Home	Second Floor	No asbestos detected
	Area/Location/Position	Material description	Quantity	Confirmation of product type
	079 - Store - Vinyl flooring below carpet	Vinyl product	N/A	Non-asbestos material
	Product type	Condition	Surface Treatment	Asbestos type
	-	-	-	-
Material Risk Score	Priority Risk Score	Total Risk Score	Accessibility	
0	-	0	-	
Recommended action	-			
Recommendation comments	-			
Surveyor comments	-

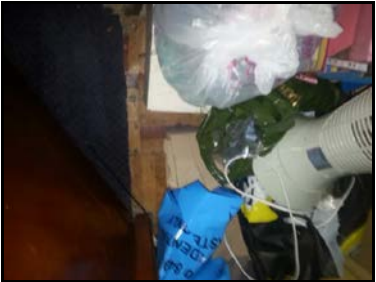
Sample No	Building	Floor	Analysis
	p-166740/020	Torwood Hall Care Home	Second Floor	No asbestos detected
	Area/Location/Position	Material description	Quantity	Confirmation of product type
	080 - Cupboard. - Vinyl flooring	Vinyl product	N/A	Non-asbestos material
	Product type	Condition	Surface Treatment	Asbestos type
	-	-	-	-
Material Risk Score	Priority Risk Score	Total Risk Score	Accessibility	
0	-	0	-	
Recommended action	-			
Recommendation comments	-			
Surveyor comments	-

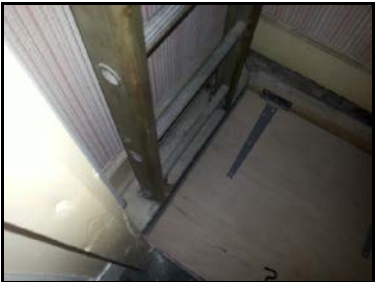
Sample No	Building	Floor	Analysis
	p-166740/021	Torwood Hall Care Home	Second Floor	No asbestos detected
	Area/Location/Position	Material description	Quantity	Confirmation of product type
	083 - Cupboard - Vinyl flooring	Vinyl product	N/A	Non-asbestos material
	Product type	Condition	Surface Treatment	Asbestos type
	-	-	-	-
	Material Risk Score	Priority Risk Score	Total Risk Score	Accessibility
0	-	0	-	
Recommended action	-			
Recommendation comments	-			
Surveyor comments	-

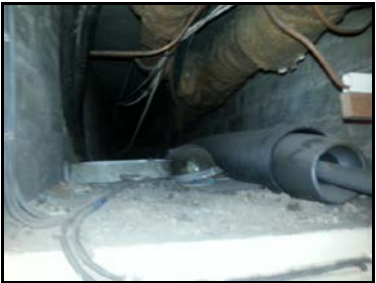
Sample No	Building	Floor	Analysis
	p-166740/026	Torwood Hall Care Home	First Basement Level	No asbestos detected
	Area/Location/Position	Material description	Quantity	Confirmation of product type
	092 - Circulation - Damp proof course	Bituminous products	N/A	Non-asbestos material
	Product type	Condition	Surface Treatment	Asbestos type
	-	-	-	-
	Material Risk Score	Priority Risk Score	Total Risk Score	Accessibility
0	-	0	-	
Recommended action	-			
Recommendation comments	-			
Surveyor comments	Damp proof course is visible around hole in wall for exiting pipes.

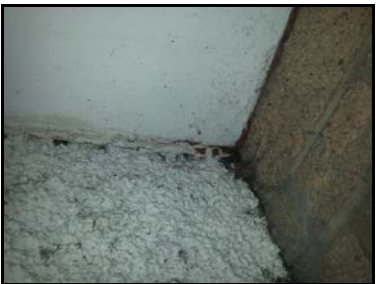
Sample No	Building	Floor	Analysis
	p-166740/033	Torwood Hall Care Home	External	No asbestos detected
	Area/Location/Position	Material description	Quantity	Confirmation of product type
	096 - Externals - Insulating board panel above door leading to circulation (047)	Insulating board	N/A	Non-asbestos material
	Product type	Condition	Surface Treatment	Asbestos type
	-	-	-	-
	Material Risk Score	Priority Risk Score	Total Risk Score	Accessibility
0	-	0	-	
Recommended action	-			
Recommendation comments	-			
Surveyor comments	-

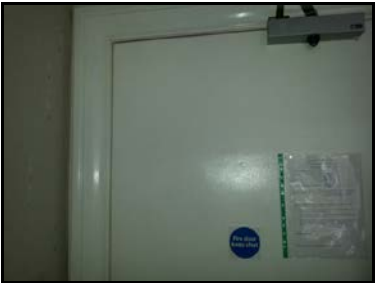
Sample No	Building	Floor	Analysis
	p-166740/035	Torwood Hall Care Home	First Floor	No asbestos detected
	Area/Location/Position	Material description	Quantity	Confirmation of product type
	100 - Bedroom 15 - Insulating board panel to door	Insulating board	N/A	Non-asbestos material
	Product type	Condition	Surface Treatment	Asbestos type
	-	-	-	-
Material Risk Score	Priority Risk Score	Total Risk Score	Accessibility	
0	-	0	-	
Recommended action	-			
Recommendation comments	-			
Surveyor comments	-

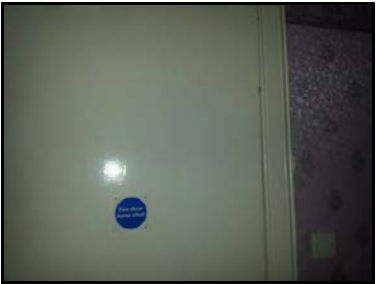
Sample No	Building	Floor	Analysis
	p-166740/036	Torwood Hall Care Home	First Floor	No asbestos detected
	Area/Location/Position	Material description	Quantity	Confirmation of product type
	102 - Bedroom 14 - Insulating board panel to door	Insulating board	N/A	Non-asbestos material
	Product type	Condition	Surface Treatment	Asbestos type
	-	-	-	-
Material Risk Score	Priority Risk Score	Total Risk Score	Accessibility	
0	-	0	-	
Recommended action	-			
Recommendation comments	-			
Surveyor comments	-

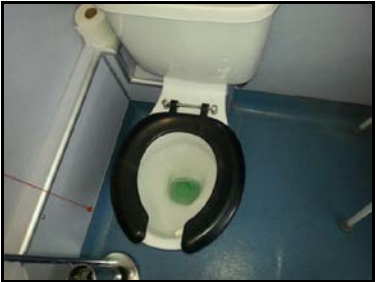
Sample No	Building	Floor	Analysis
	p-166740/037	Torwood Hall Care Home	First Floor	No asbestos detected
	Area/Location/Position	Material description	Quantity	Confirmation of product type
	109 - Bathroom - Toilet seat	Reinforced plastic	N/A	Non-asbestos material
	Product type	Condition	Surface Treatment	Asbestos type
	-	-	-	-
	Material Risk Score	Priority Risk Score	Total Risk Score	Accessibility
0	-	0	-	
Recommended action	-			
Recommendation comments	-			
Surveyor comments	-

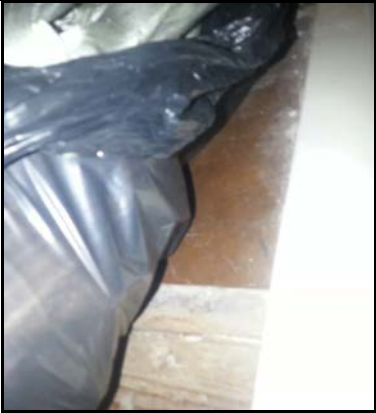
Sample No	Building	Floor	Analysis
	p-166740/As 018	Torwood Hall Care Home	Second Floor	Strongly presumed: No asbestos detected
	Area/Location/Position	Material description	Quantity	Confirmation of product type
	078 - Store - Vinyl flooring	Vinyl product	N/A	Strongly presumed: Non-asbestos material
	Product type	Condition	Surface Treatment	Asbestos type
	-	-	-	-
	Material Risk Score	Priority Risk Score	Total Risk Score	Accessibility
0	-	0	-	
Recommended action	-			
Recommendation comments	-			
Surveyor comments	-
